Coefficient of Friction Test for Sound Stage 33, Project “Strongarm”

March 10 – 12, 2008

Location: Sound Stage 33

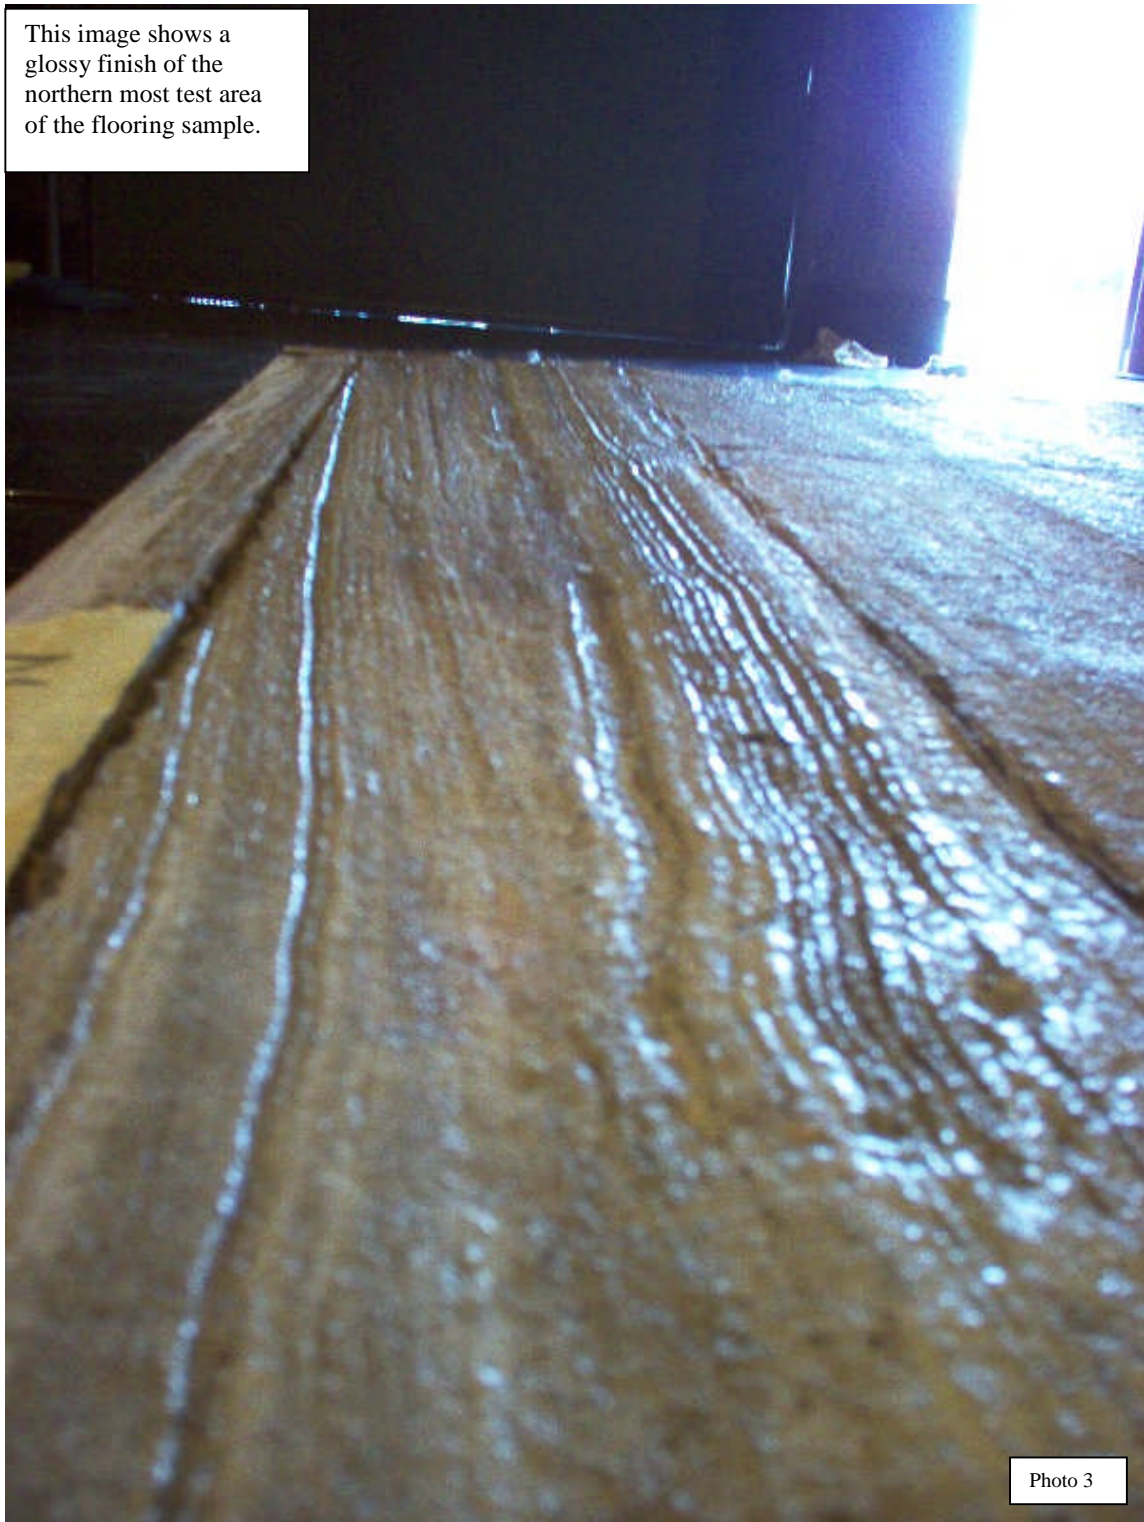
Photo 3

This image shows a glossy finish of the northern most test area of the flooring sample.

Based on the mock up results, the concrete textured flooring sealed with SCOFILED® Cureseal-S™ makes a suitable walking surface. All areas predicted to be employee and guest walk ways should remain as rough as possible and efforts to eliminate a glossy surface should be taken during construction and thereafter. Pictures were taken of the sample floor areas that were glossy and gave the lowest of results of the SCOF testing; see attached photos.

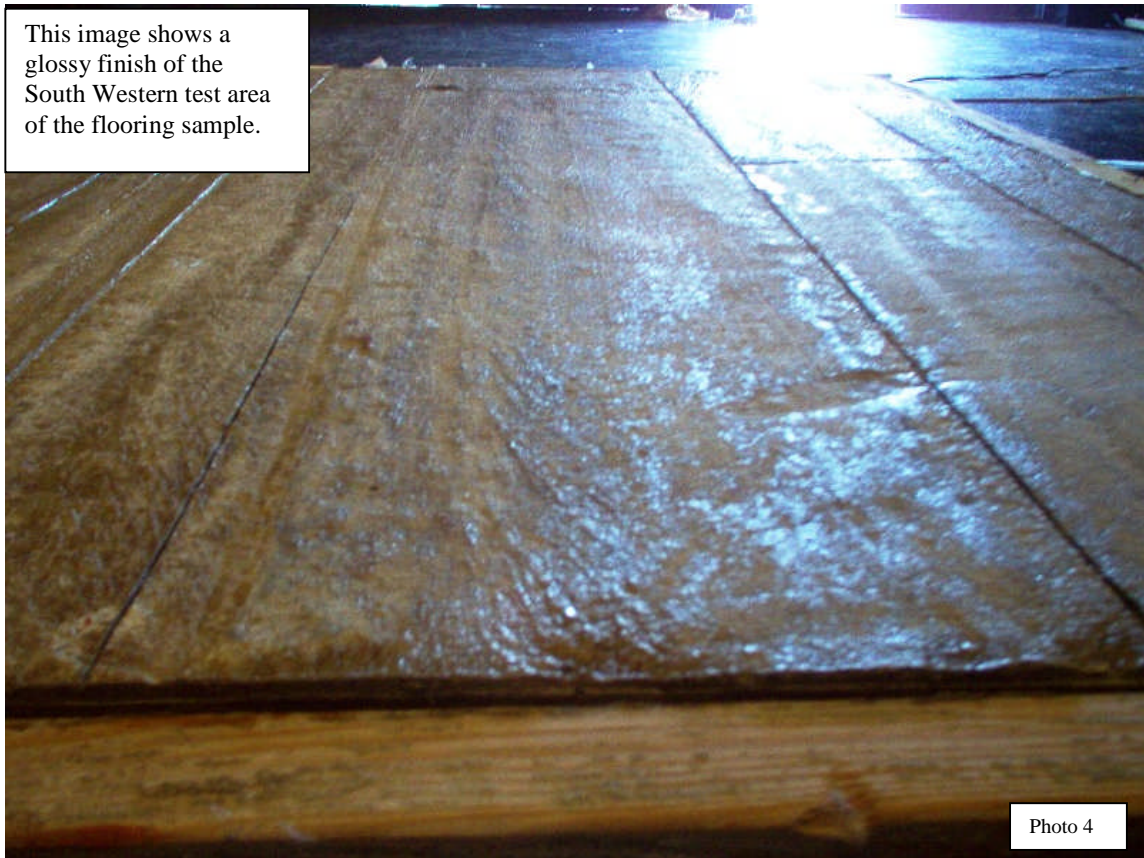
Photo 4

This image shows a glossy finish of the South Western test area of the flooring sample.
